INDOOR AIR QUALITY ASSESSMENT

**Bryantville Elementary School
29 Gurney Drive
Pembroke, Massachusetts**

Prepared by:
Massachusetts Department of Public Health
Center for Environmental Health
Bureau of Environmental Health Assessment
Emergency Response/Indoor Air Quality Program
March 2005

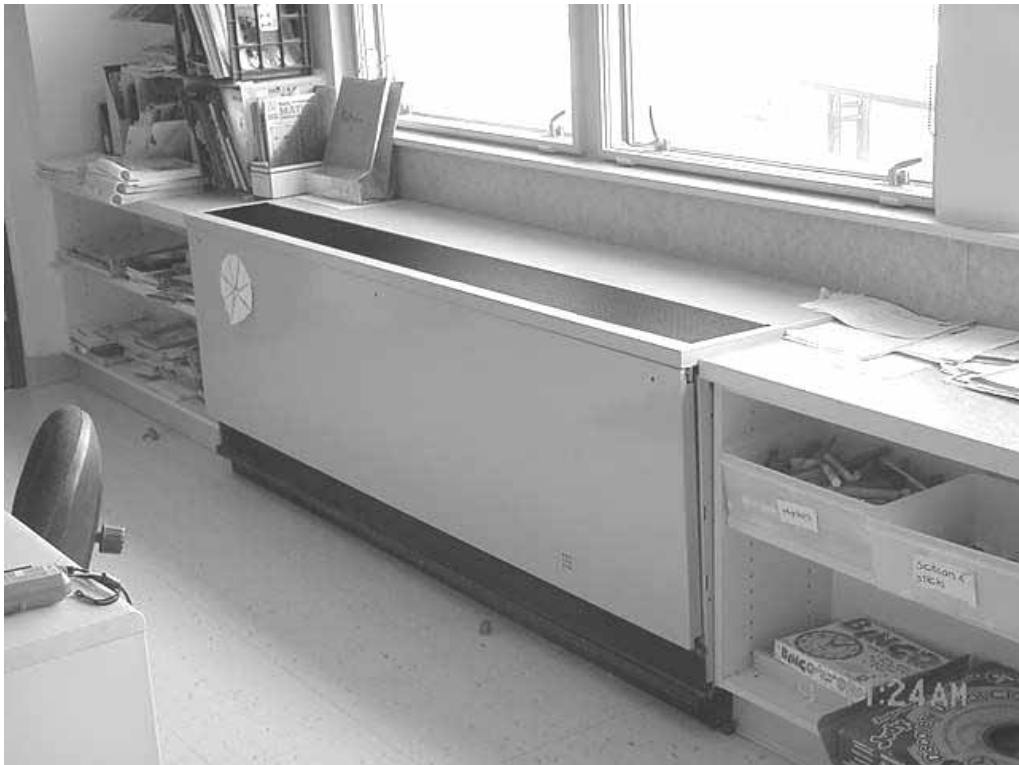
Picture 1

some areas. Fresh air in classrooms is mechanically supplied by unit ventilator (univent) systems (Picture 1). A univent draws air from outdoors through a fresh air intake located on the exterior wall of the building (Picture 2) and returns air through an air intake located at the base of the unit. Fresh and return air are mixed, filtered, heated and provided to classrooms through an air diffuser located in the top of the unit ([Figure 1](#)). Univents were found activated in all but one classroom surveyed. To function as designed, univents must be activated while classrooms are occupied.

Classroom Univent

2. Remove all blockages from univents and exhaust vents to ensure adequate airflow. Close classroom doors to improve exhaust ventilation.
3. Consider adopting a balancing schedule of every 5 years for mechanical ventilation systems, as recommended by ventilation industrial standards (SMACNA, 1994).

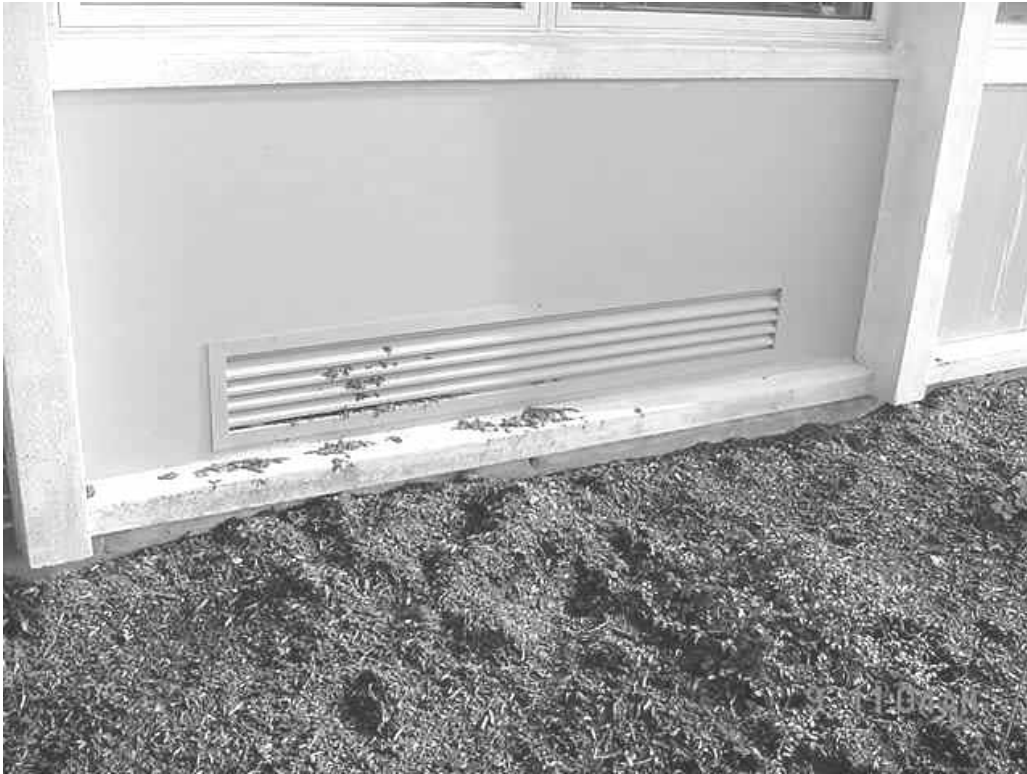
Picture 2

Univent Fresh Air Intake

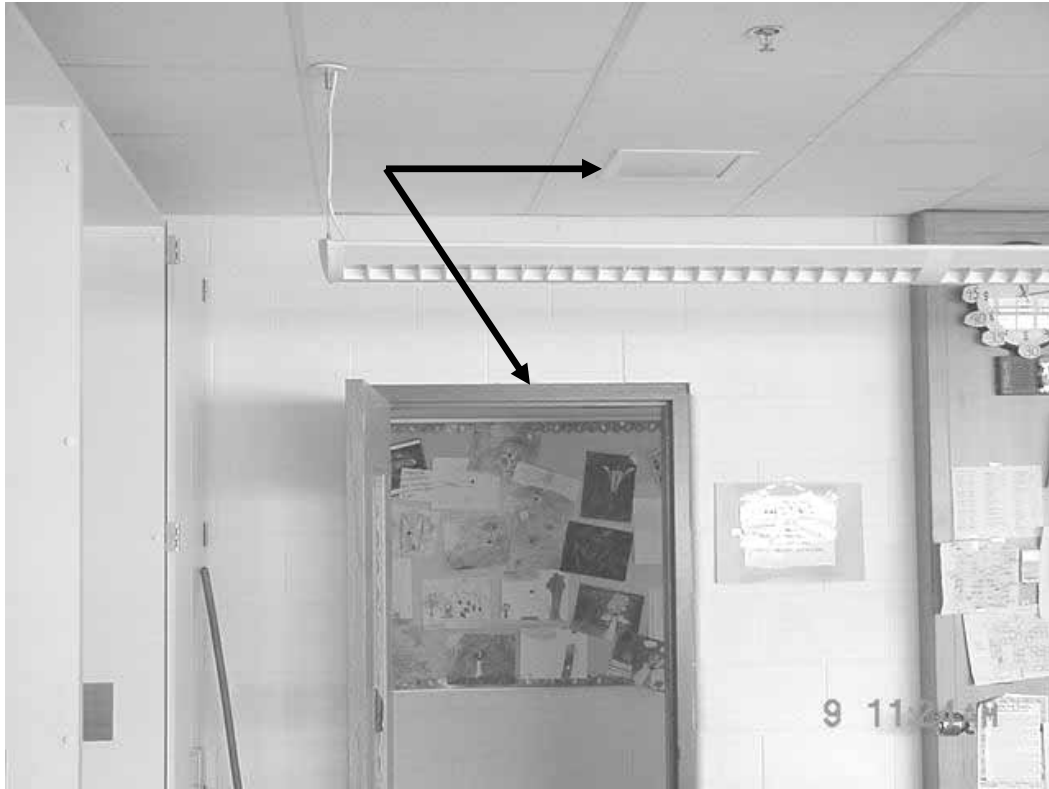
Picture 3

Exhaust ventilation in classrooms is provided by ducted, grated ceiling or wall vents (Picture 3) powered by rooftop motors. These vents were operating during the assessment. It is important to note however, that the location of some exhaust vents can limit exhaust efficiency. In several areas exhaust vents are located above hallway doors (Picture 3). When classroom doors are open, exhaust vents will tend to draw air from both the hallway and the classroom, reducing the effectiveness of the exhaust vent to remove common environmental pollutants.

Close Proximity of Ceiling-Mounted Exhaust Vent to Open Classroom Door

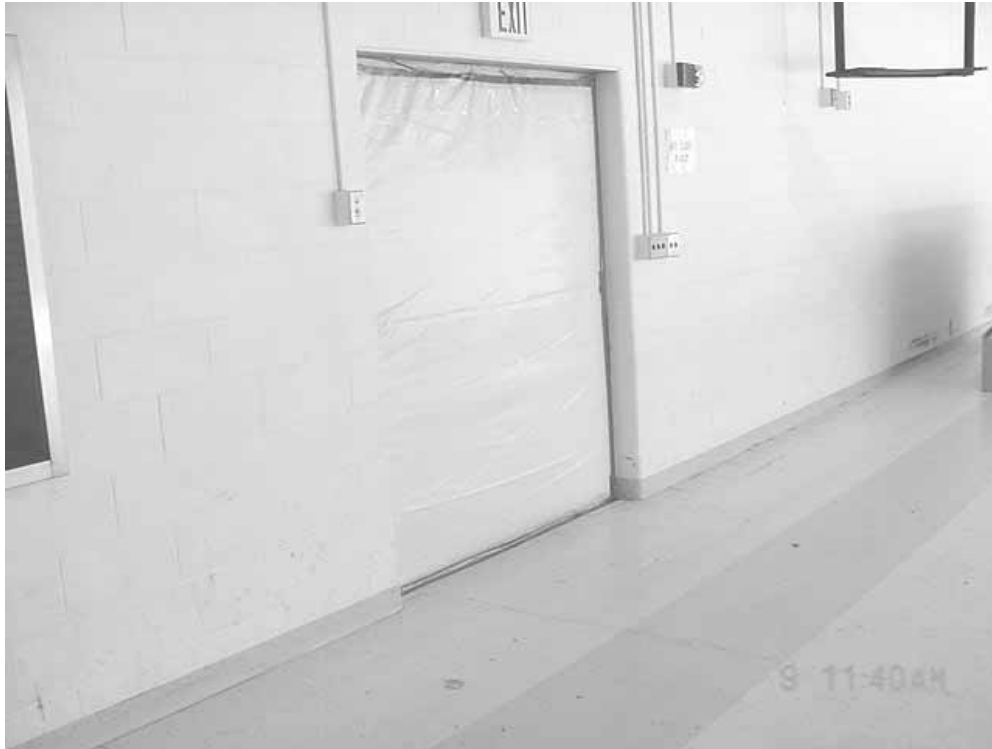
Picture 4

It is important to note that during both MDPH assessments the cafeteria was sealed using plastic polyethylene sheeting and duct tape on the interior, as well as the exterior of cafeteria doors to provide a dual barrier (Pictures 4 and 5). To enhance containment, an airlock or pressurized buffer zone was created by sealing off and mechanically introducing large amounts of outside air into the corridor outside the cafeteria (Pictures 6 and 7).

Interior of Cafeteria Door Sealed with Polyethylene Plastic Sheeting and Duct Tape

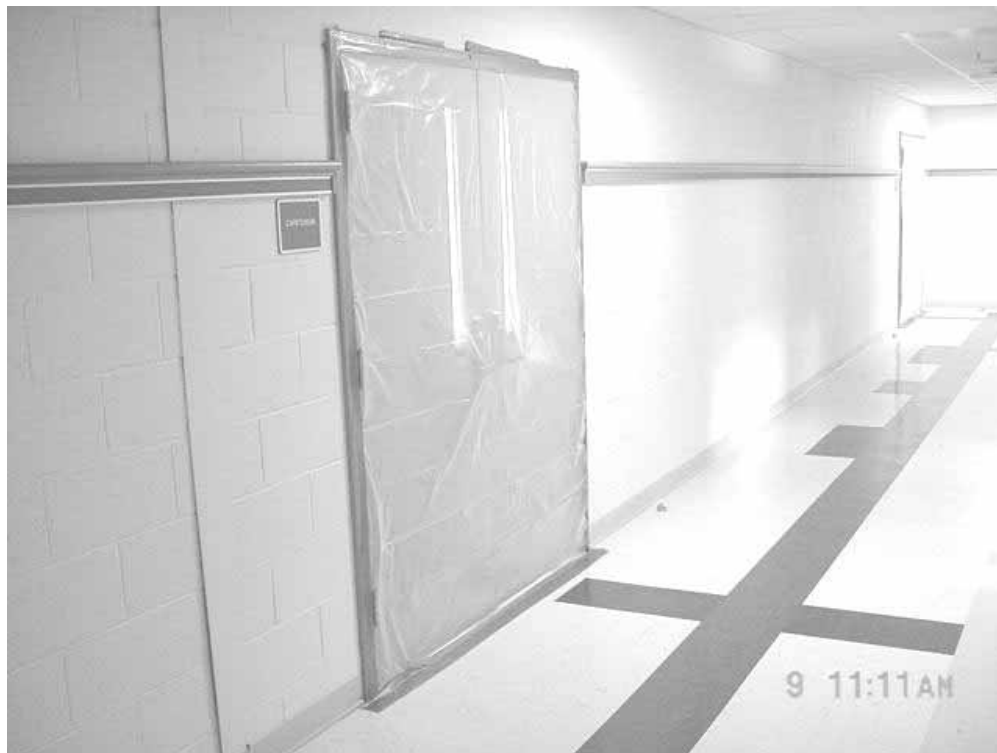
Picture 5

Exterior of Cafeteria Doors Sealed with Polyethylene Plastic Sheeting and Duct Tape

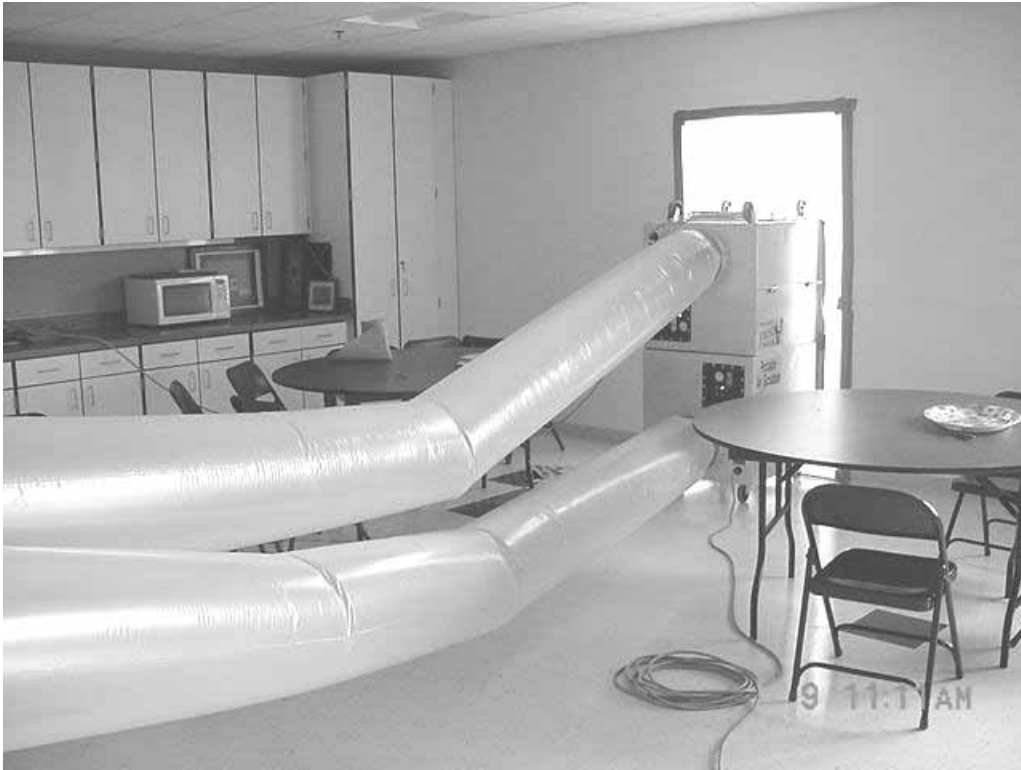
Picture 6

Outside Air Mechanically Introduced into the Hallway Adjacent to the Cafeteria via Flexible Ductwork

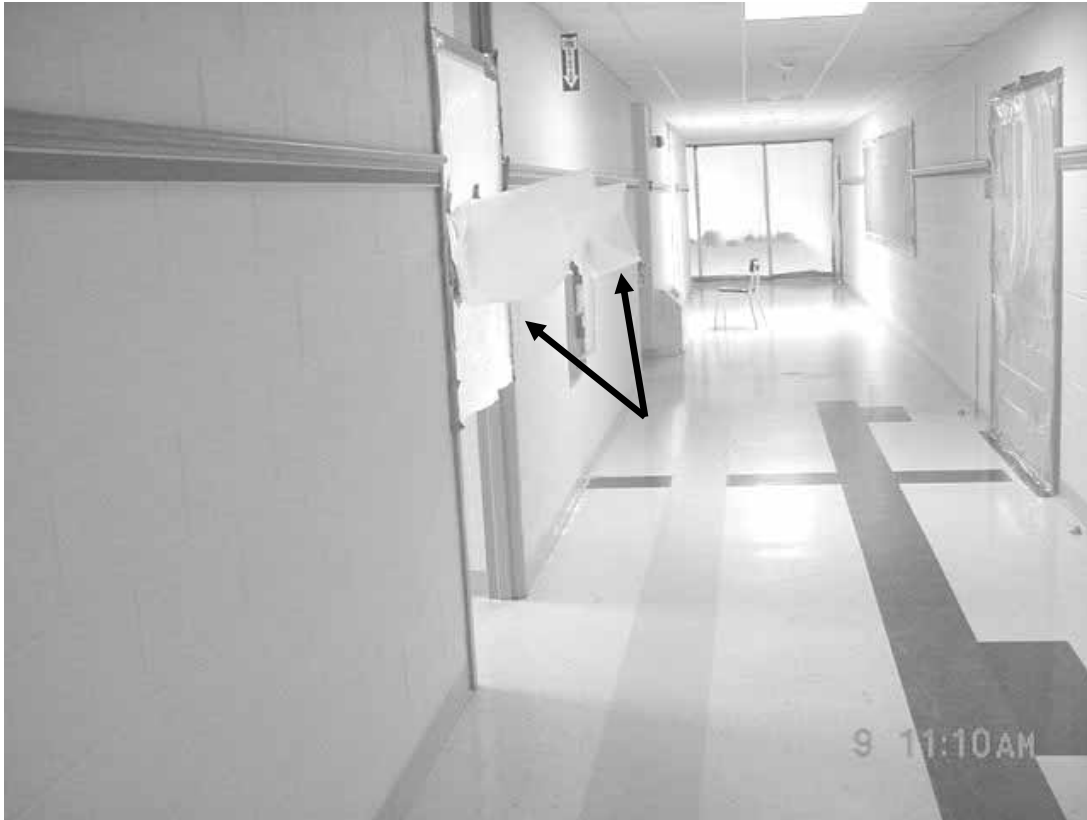
Picture 7

**“Pressurized” Hallway Adjacent to the Cafeteria Note Ends of Flexible Ductwork
Introducing Outside Air**

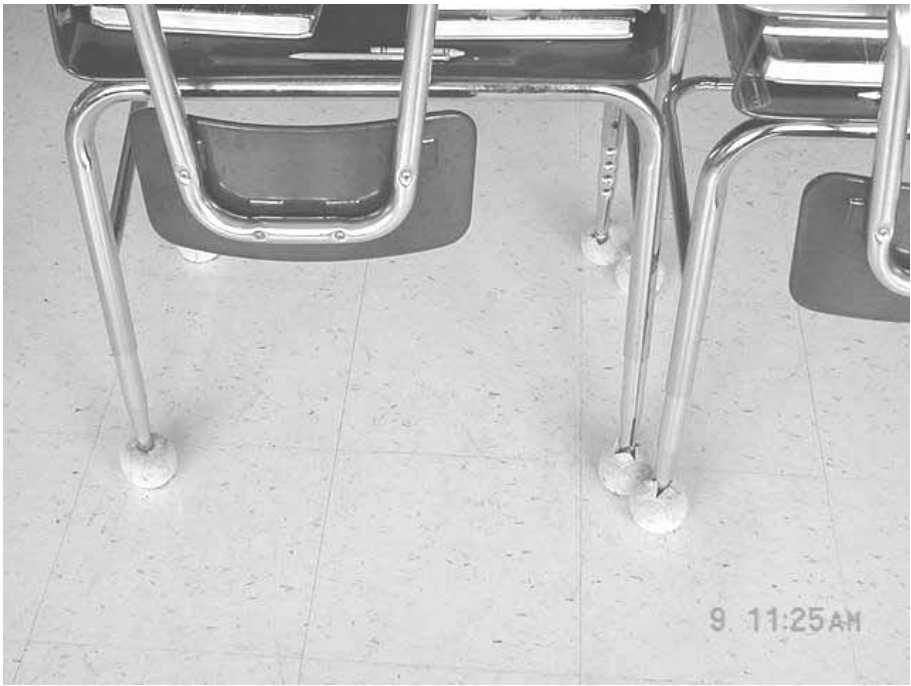
Picture 8

In an effort to reduce noise from sliding chairs, tennis balls had been sliced open and placed on chair legs (Picture 8). Tennis balls are made of a number of materials that are a source of respiratory irritants. Constant wearing of tennis balls can produce fibers and off-gas TVOCs. Tennis balls are made with a natural rubber latex bladder, which becomes abraded when used as a chair leg pad. Use of tennis balls in this manner may introduce latex dust into the school environment. Some individuals are highly allergic to latex (e.g., spina bifida patients) (SBAA, 2001). It is recommended that the use of materials containing latex be limited in buildings to reduce the likelihood of symptoms in sensitive individuals (NIOSH, 1997). A question and answer sheet concerning latex allergy is attached as [Appendix B](#) (NIOSH, 1998).

Tennis Balls on Chair Legs

6. Store cleaning products properly and out of reach of students. Ensure spray bottles are properly labeled in case of emergency.
 7. Consider discontinuing the use of tennis balls on chair/desk legs to prevent latex dust generation. Alternative “glides” can commonly be purchased from office supply stores, see Picture 9 for an example.

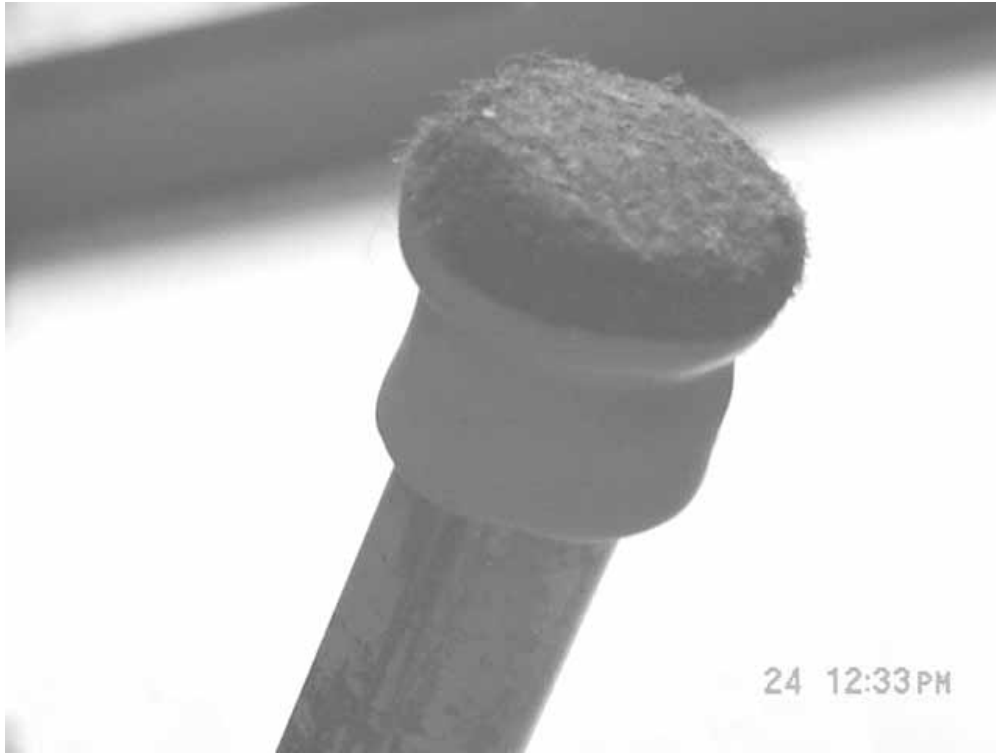
Picture 9

“Glides” for Chair Legs that can be used as an Alternative to Tennis Balls
